# Polyurea coating for asbestos

Coating for asbestos encapsulation

Old Shipyard Centre,  
Bridport, Dorset

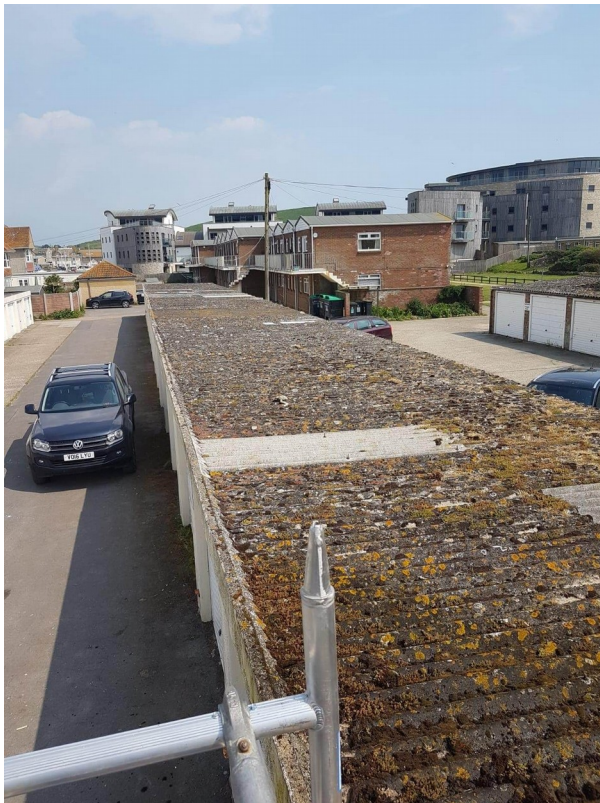
Before

Block of 18 garages with old and fragile cementitious corrugated roof tiles had numerous leaks. The customer's budget did not stretch to having the roof removed and replaced due the presence of asbestos.
